Dealing with older existing weatherboards and broadwall areas

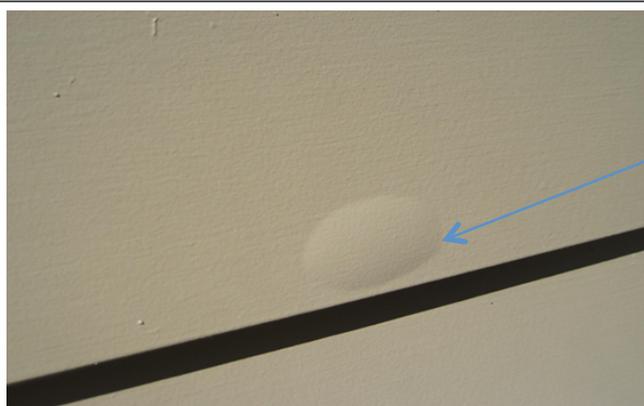
At MPNZA our attention is being drawn, on a regular basis, to failing paint coatings on freshly painted existing weatherboards. We are seeing weatherboards, which when prepared for repainting, the paint coating appears sound. Shortly after completion of the repainting, blistering and peeling are evident. This peeling and blistering goes back through many coats to the original primers when the weatherboard was first painted, often many years before.

The advent of modern acrylic coating systems, with their ability to expand and contract with temperature, places massive tension on previous coats. These previous coats are often many years old and were never intended to last the 30 plus years they have sat on the weatherboard and broadwall areas. The constant expansion and contraction of the new coating results in these older existing coatings delaminating. The use of darker colours exacerbates this tremendously due to the increased heat absorbed by the darker paint coating causing movement in the timber as well as the new paint coating. Also remember that old enamel paint is impervious and will not allow the transfer of vapour to outside of the house, as acrylics will. Thus moisture will build up behind old enamel and also cause the blister, if the enamel is already weakened by the new acrylics applied over the years, bubbling will be worse. Paint manufacturers are able to place greater and greater guarantees on the longevity of their exterior broadwall products because of the flexibility of these modern coating systems. When a paint manufacturer can place a 15 year guarantee on the paint product it is probably not unreasonable for the consumer to expect the paint job to last this long.

Typical blistering when delamination of older paint coats under new paint coating occurs.

Master Painters NZ Association recommends that consideration be given to removing all existing paint coatings from timber weatherboards and any other broadwall surfaces to be repainted that are **older than 25 years**. While this will increase the cost of repainting to the consumer, failure to remove the existing coating is likely to result in the failure of the new coating with costly ramifications for the painting contractor. It is highly recommended the attention of the consumer should be drawn to this likely problem during the quotation and assessment of the work to be carried out and before any repainting takes place. Testing for lead based coats should be carried out prior to the removal of the paint coating.
